MEMORANDUM

| Re: | Post-TCRA Semi-Annual Inspection Report – January/April 2015 Inspection | | |

San Jacinto River Waste Pits Superfund Site

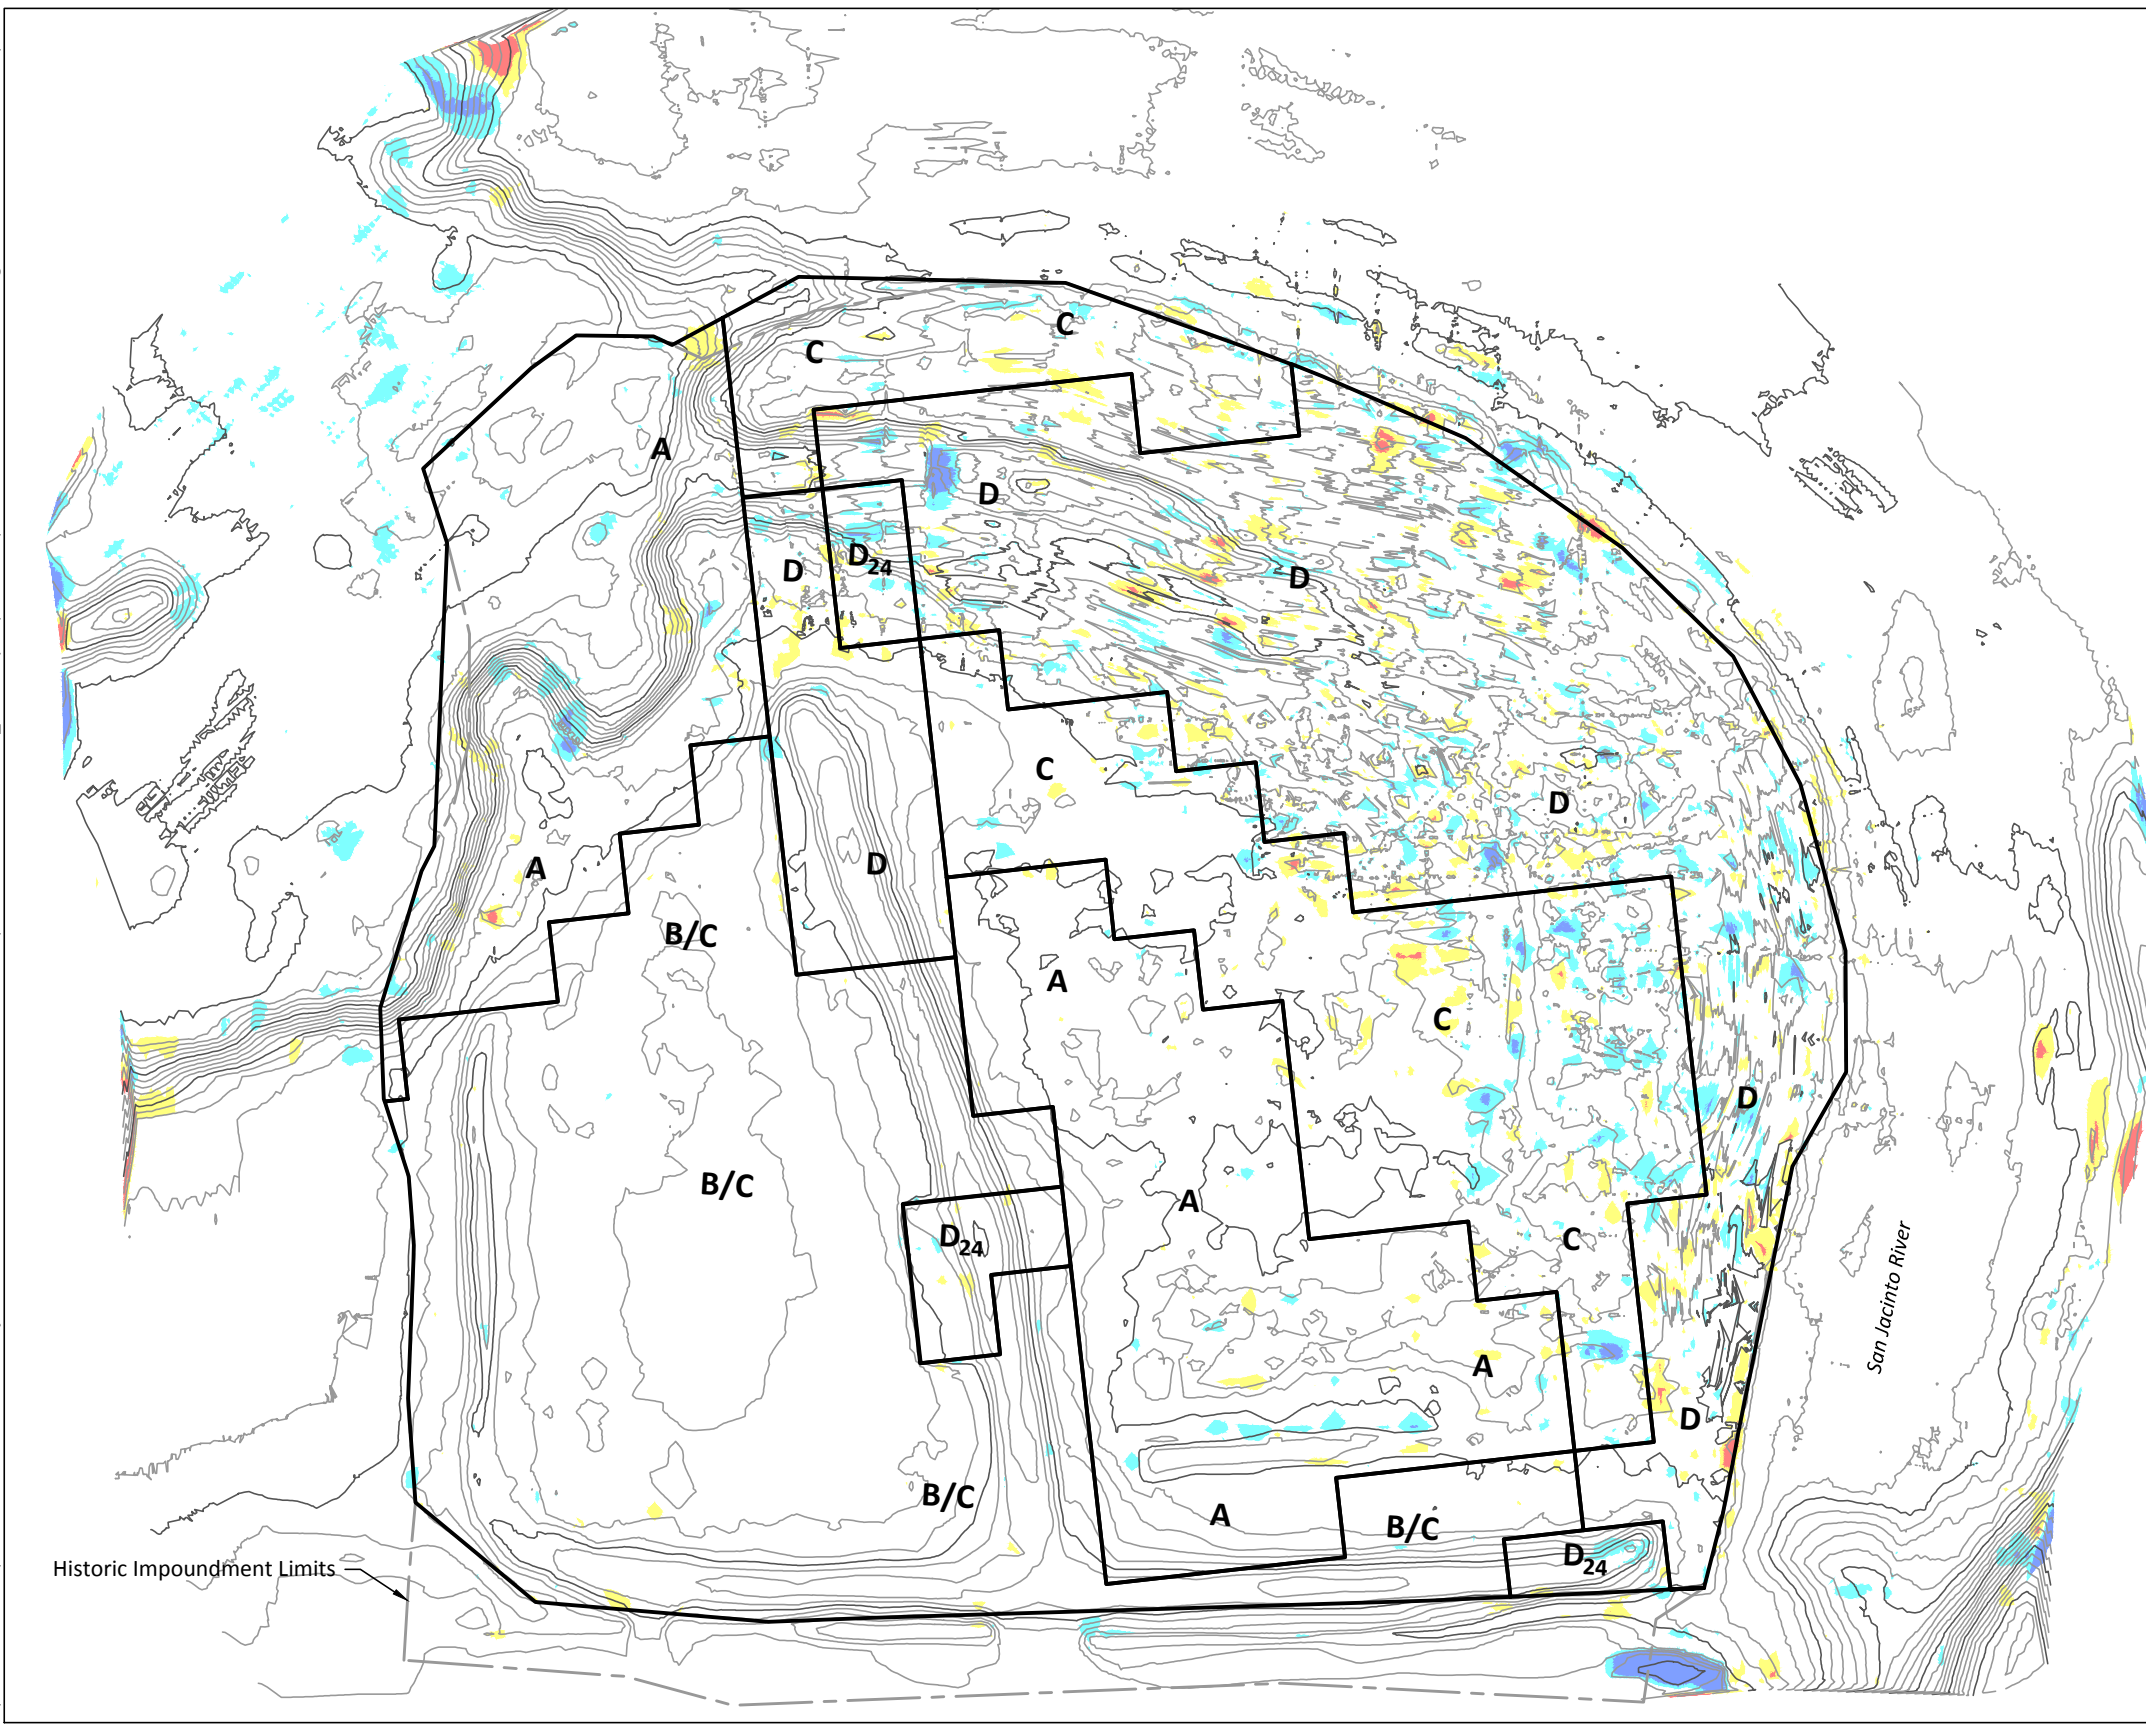
Figure 3 - January 2015 Semi-Annual Inspection Survey

The survey data from the January and April 2015 surveys and the July 2014 inspection survey were compared to evaluate the differences in the top of the armored cap elevation. These differences are shaded and shown in Figure 3. The survey results indicate continued sedimentation/deposition on the surface of the armored cap in submerged areas.

Manual probing of armored cap thickness is required at areas identified by the topographic or hydrographic surveys as more than 6 inches lower in elevation than during the prior survey over contiguous areas of 30 feet by 30 feet. When the 2015 and July 2014 surveys were compared, the results indicated that there were no areas that met the manual probing requirement. Therefore, no probing was conducted as part of the January/April 2015 inspection.

The small areas identified as increases and decreases in elevation can be attributed to the horizontal and vertical limitations of the survey, minor shifts in track line location from the baseline survey, and elevation data recorded in the crevices between rock surfaces or atop shellfish growth. The potential for these types of variations between the two datasets to exist was confirmed by the surveyor after reviewing the data collected during this inspection.

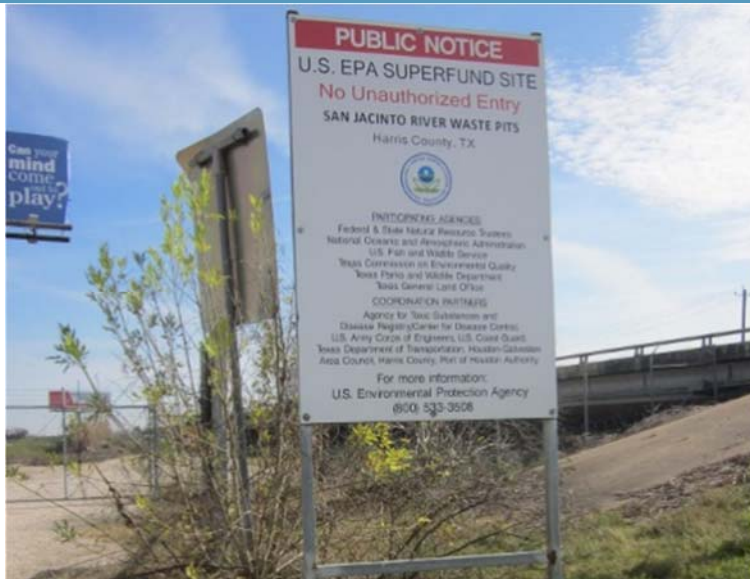
Three USEPA Public Notice signs are present around the TCRA Site located: 1) near the gate entry point for the perimeter fence north of I-10; 2) near a gate entry point south of I-10; and 3) at the end of the TxDOT right-of-way north of I-10 near the San Jacinto River. For examples, see Photographs 1, 5, and 15 in Appendix A. These three signs were observed to be in place and undamaged during the January 8, 2015 inspection.

Photograph 01: USEPA Public Notice Sign located outside the access gate north of I-10 (view southeast)

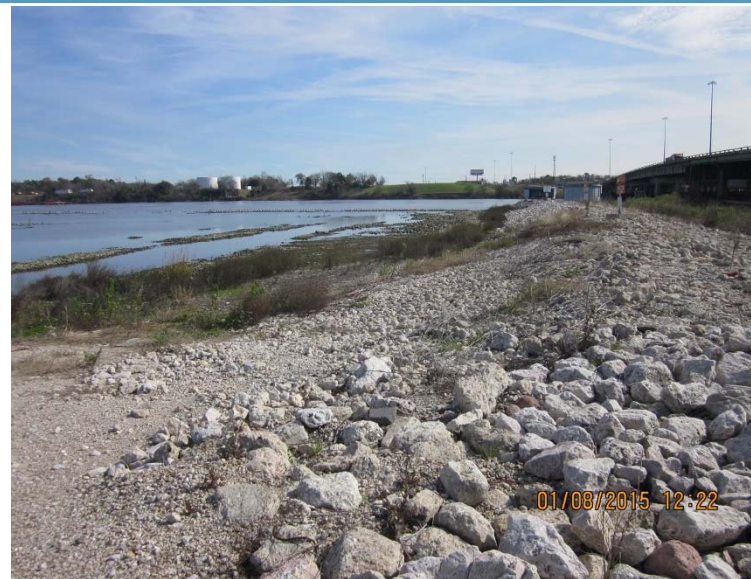
Photographs of the armored cap from the inspection event are provided in Appendix A (see photographs 2 through 12 and 19 through 20). All of the visible portions of the armored cap were observed to be intact, and no movement or erosion of waste materials into the San Jacinto River was observed at any location during the visual inspection.

A total of fifteen “Danger” and “No Trespassing” signs were installed at the TCRA Site around the perimeter of the land portion of the TCRA Site; the signs are mounted on steel posts and set in concrete pads. For examples, see Photographs 2, 4, 6 through 7, and 9 through 12 in Appendix A. These signs were observed to be in place during the visual inspection. These signs are intended to face the San Jacinto River to deter water-based entry to the TCRA Site. Several of these signs had rotated out of proper alignment due to the wind. The affected signs were re-aligned to the intended viewing perspective, and the screws fastening the signs to the steel posts were tightened.

Photograph 02: Warning signs and vegetation along southern berm (view east)

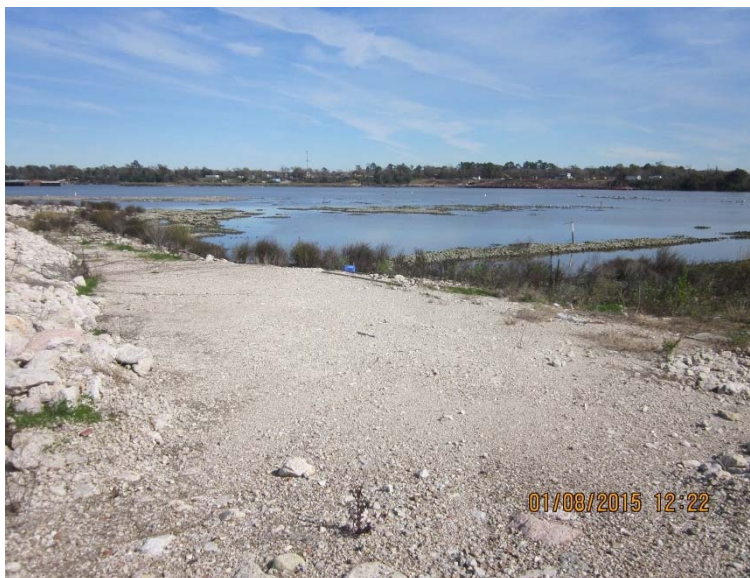
Photograph 03: Eastern Cell as viewed from intersection of southern and central berms (view northeast)

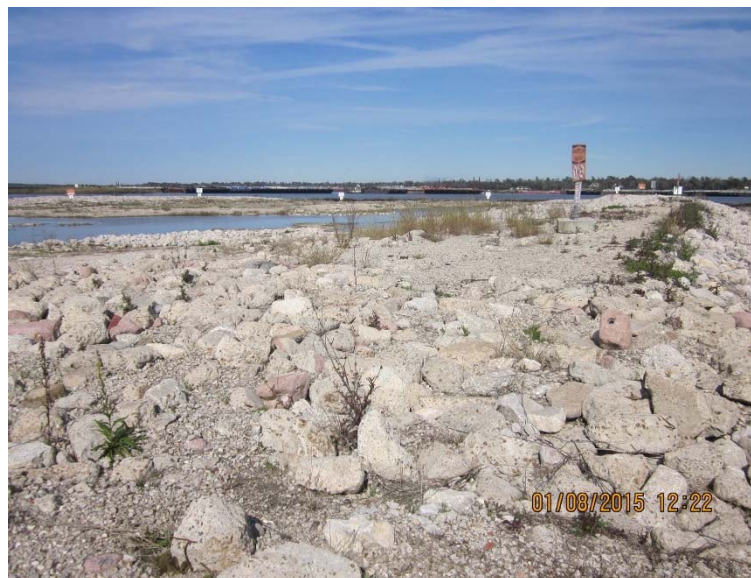
Photograph 04: Warning signs along perimeter and interior of Western Cell (view northwest)

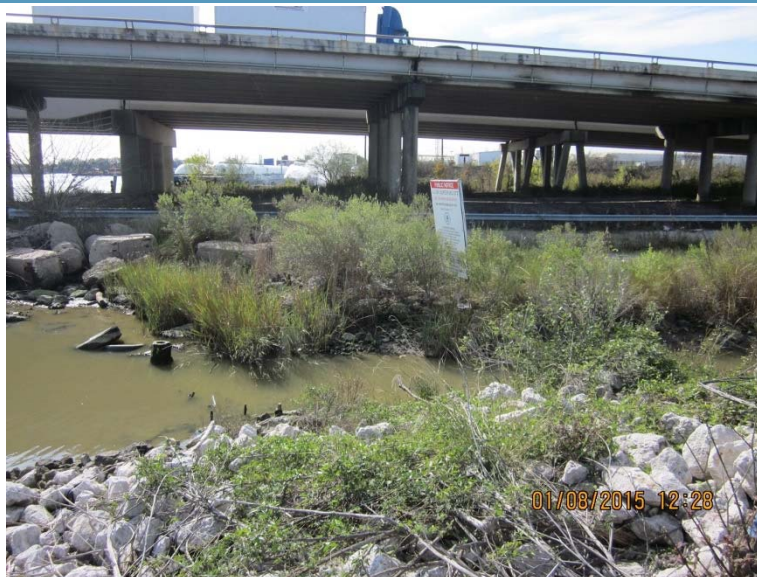
Photograph 05: USEPA Public Notice Sign located north of I-10 and along southern berm (view southwest)

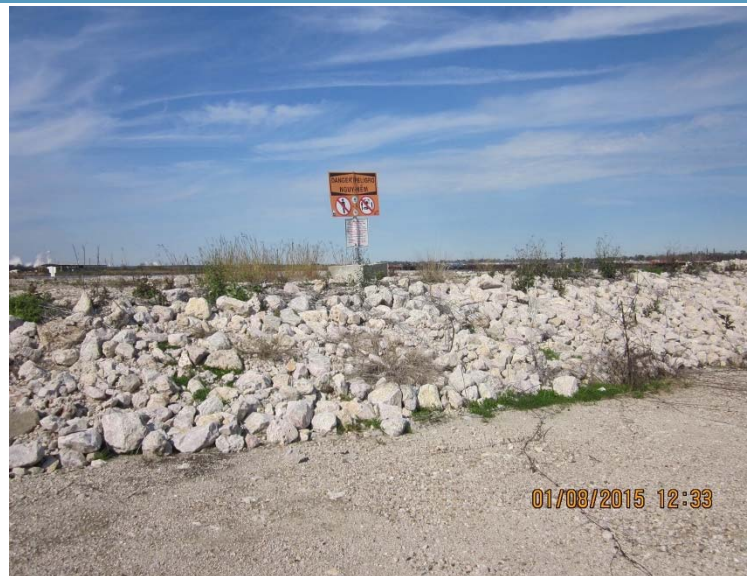
Photograph 06: Warning sign along central berm (view northwest)

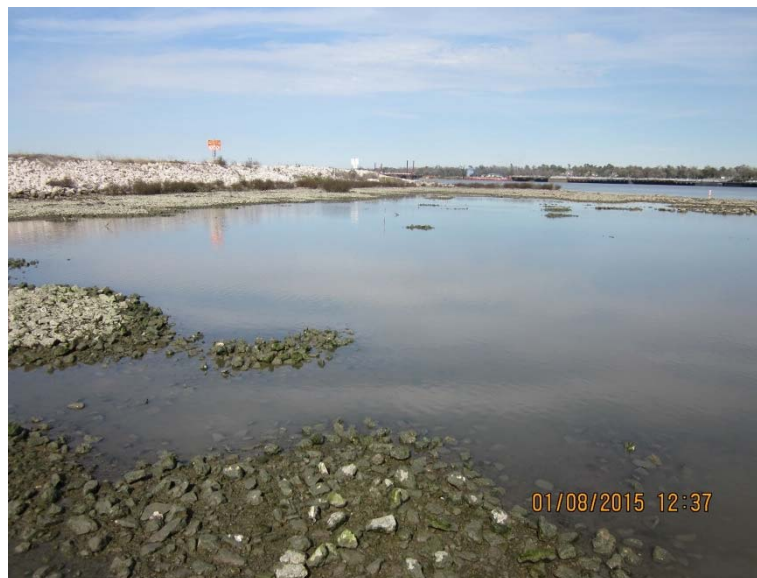
Photograph 07: Northern portion of central berm and Eastern Cell (view northwest)

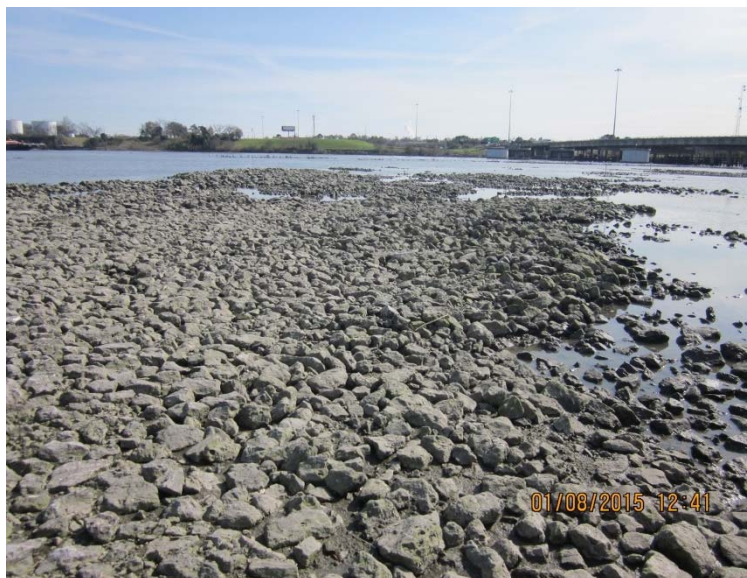
Photograph 08: Armored cap in northern portion of Eastern Cell exposed during low tides (view southeast)

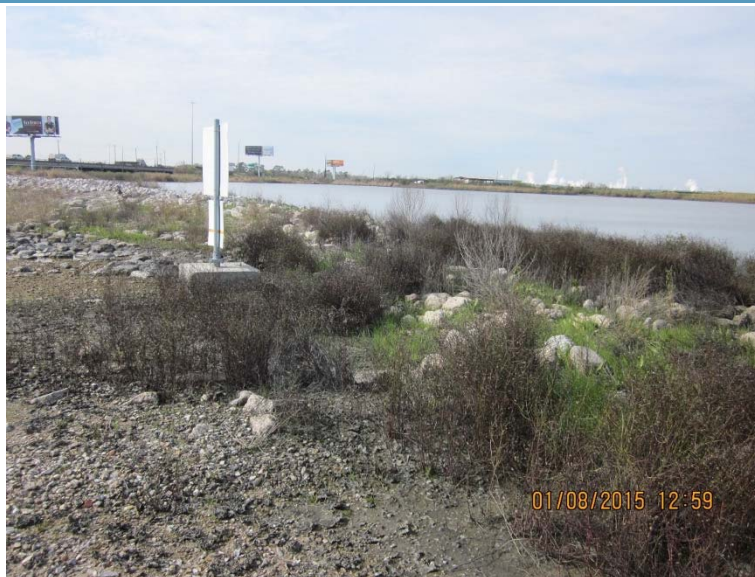
Photograph 09: Vegetation and warning sign along northern edge of Western Cell (view southwest)

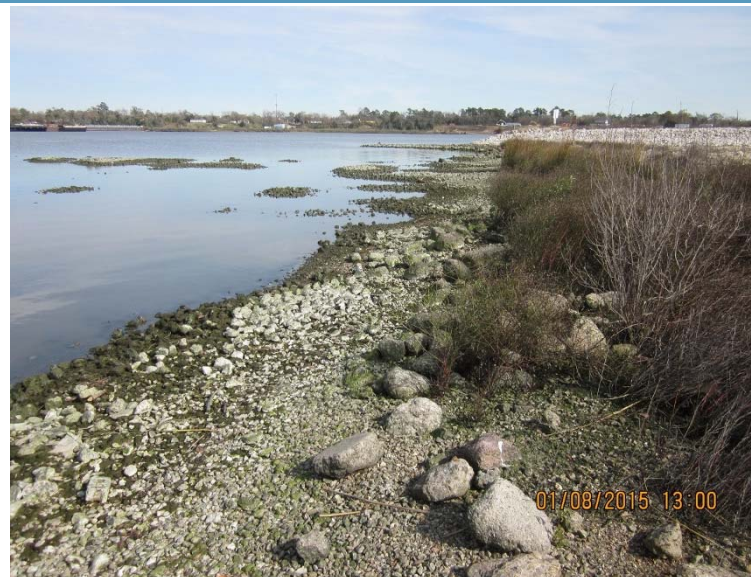
Photograph 10: Intertidal area along northern edge of Western Cell (view northeast)

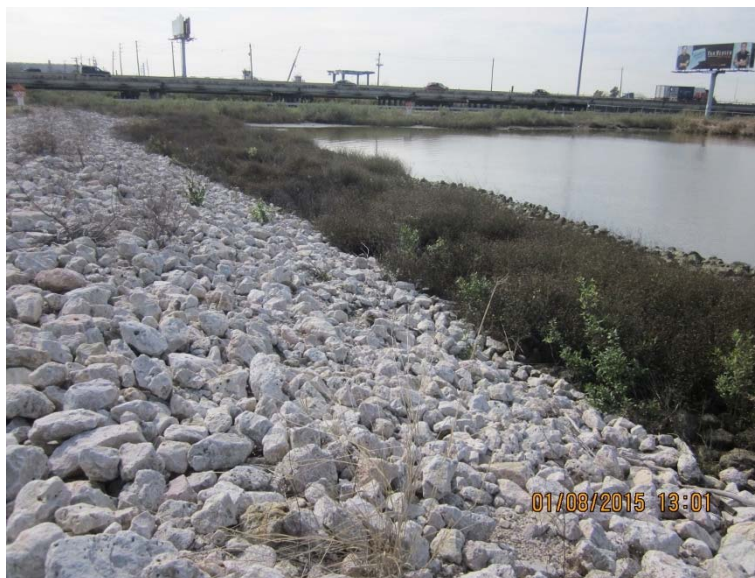
Photograph 11: Warning sign and vegetation along western berm (view southwest)

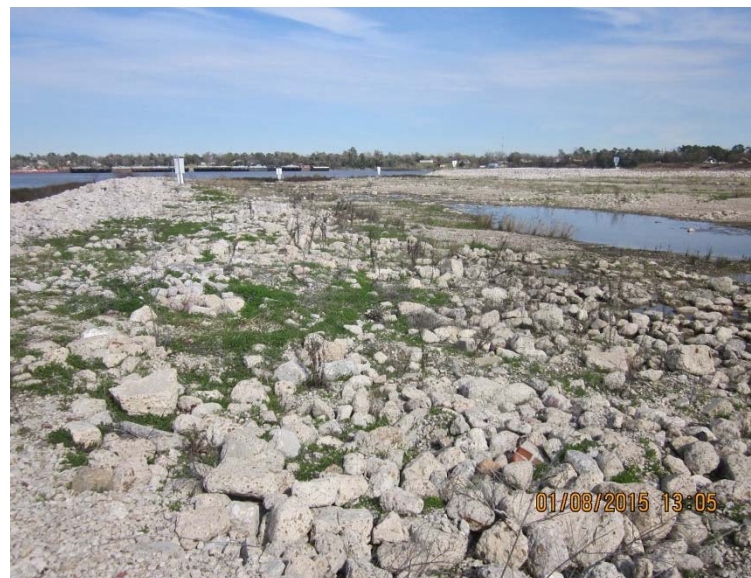
Photograph 12: Interior of Western Cell (view northeast)

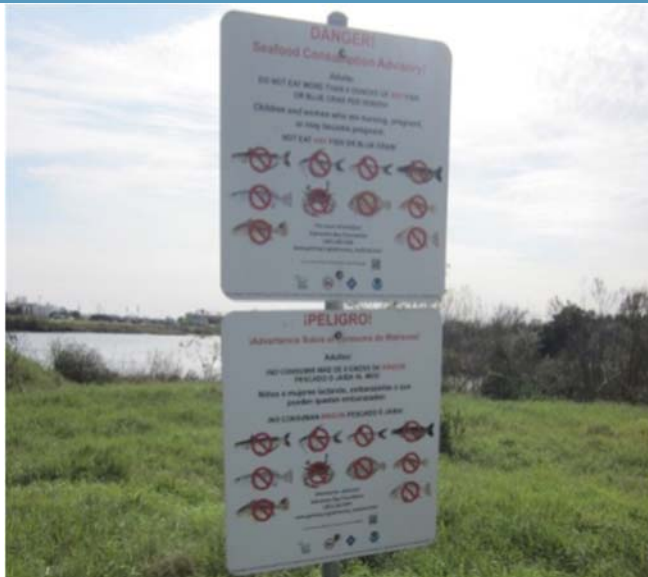
Photograph 13: Fish consumption advisory signs located south of I-10 and west of San Jacinto River (view southwest)

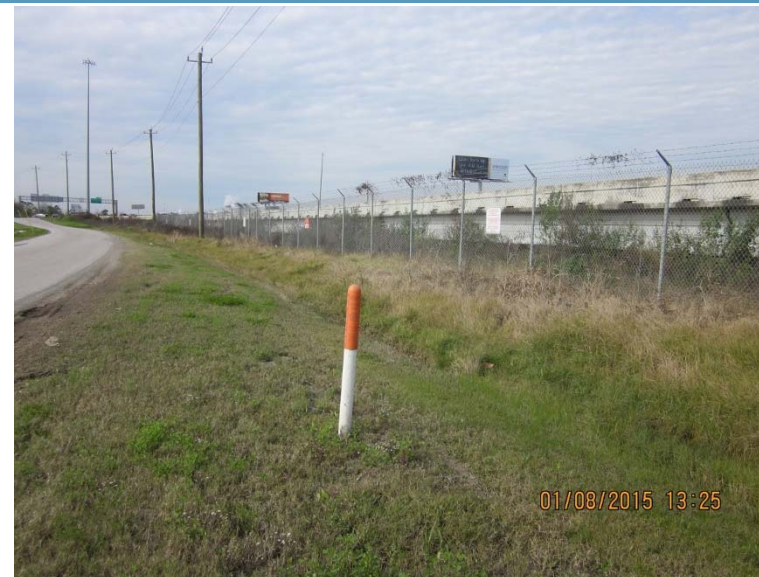
The perimeter fencing (Figure 2) on the west and east banks of the San Jacinto River was visually inspected for breaches or other signs of damage on January 8, 2015. No breaches or other signs of fence damage were observed during the inspection for any of the three sections of the fence: the east bank, the west bank on the north side of I-10, or the west bank on the south side of I-10. For examples, see Photographs 14 through 18 in Appendix A.

“Danger” and “No Trespassing” signs are posted at regular intervals on the perimeter fencing surrounding the Site. For examples, see Photographs 14 and 16 through 18 in Appendix A. These signs were observed to be in place during the January 8, 2015 inspection.

Photograph 14: Signage and perimeter fencing south of I-10 and west of San Jacinto River (view northwest)

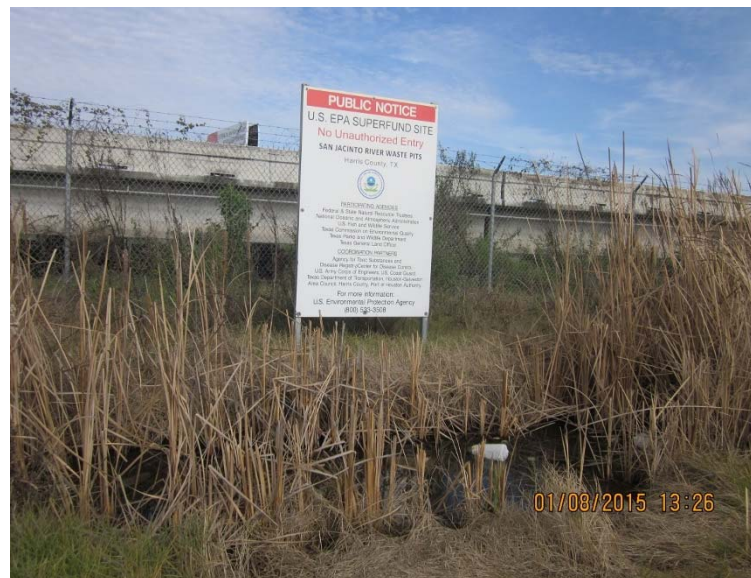
Photograph 15: USEPA Public Notice Sign located south of I-10 and west of San Jacinto River (view northeast)

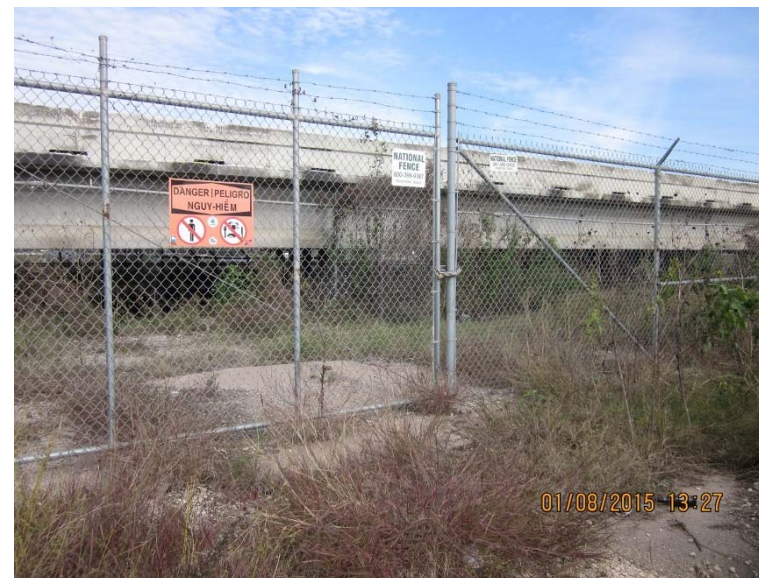
Photograph 16: Access gate south of I-10 and west of San Jacinto River (view northeast)

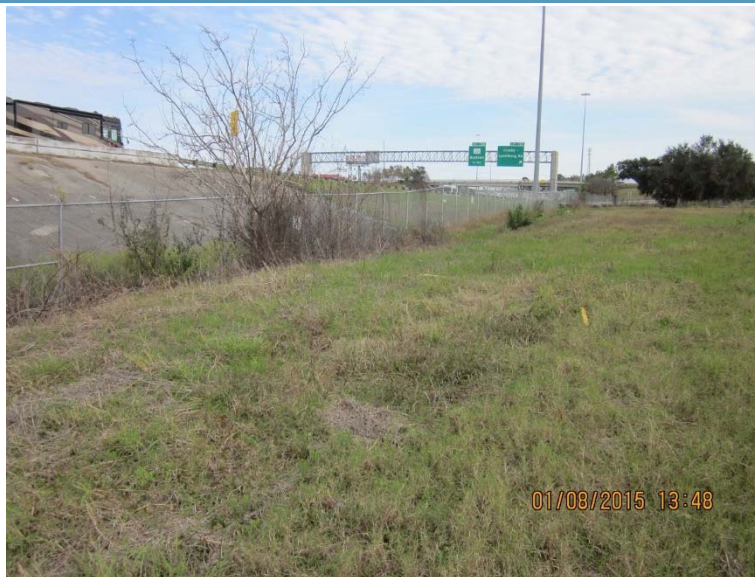
Photograph 17: Signage and perimeter fencing south of I-10 and east of San Jacinto River (view northeast)

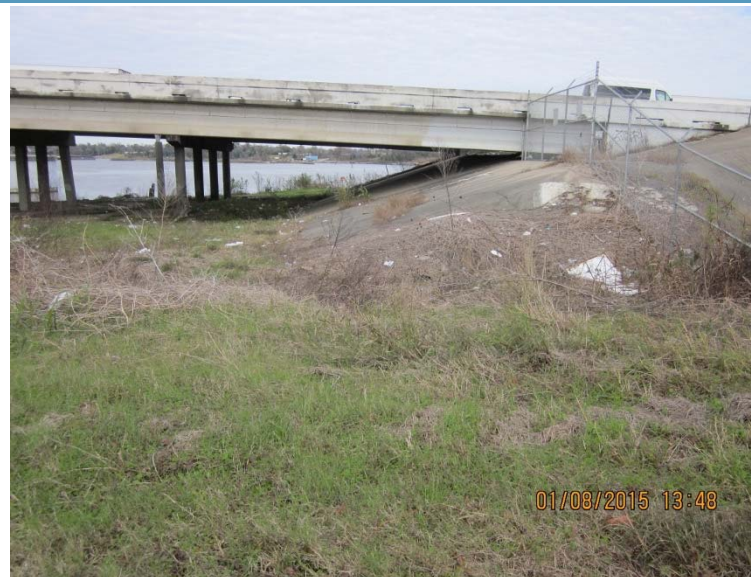
Photograph 18: Perimeter fencing south of I-10 and east of San Jacinto River (view north)

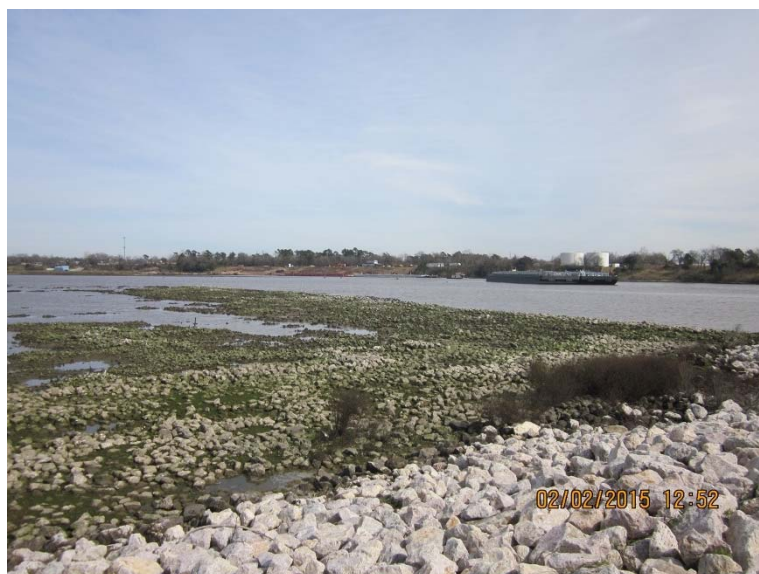
Photograph 19: View during extreme low tide, the eastern cell along the San Jacinto River (view northeast)

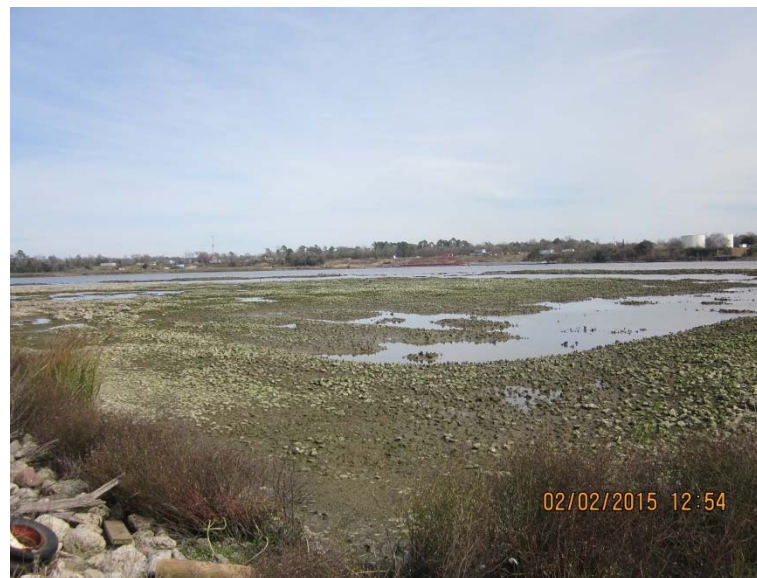
Photograph 20: View during extreme low tide of the northeast corner along the San Jacinto River (view northeast)
